CFRP CASE STUDY

# RESIDENTIAL HOME CRACK REPAIR

Walkersville, Maryland

Mission Home Services

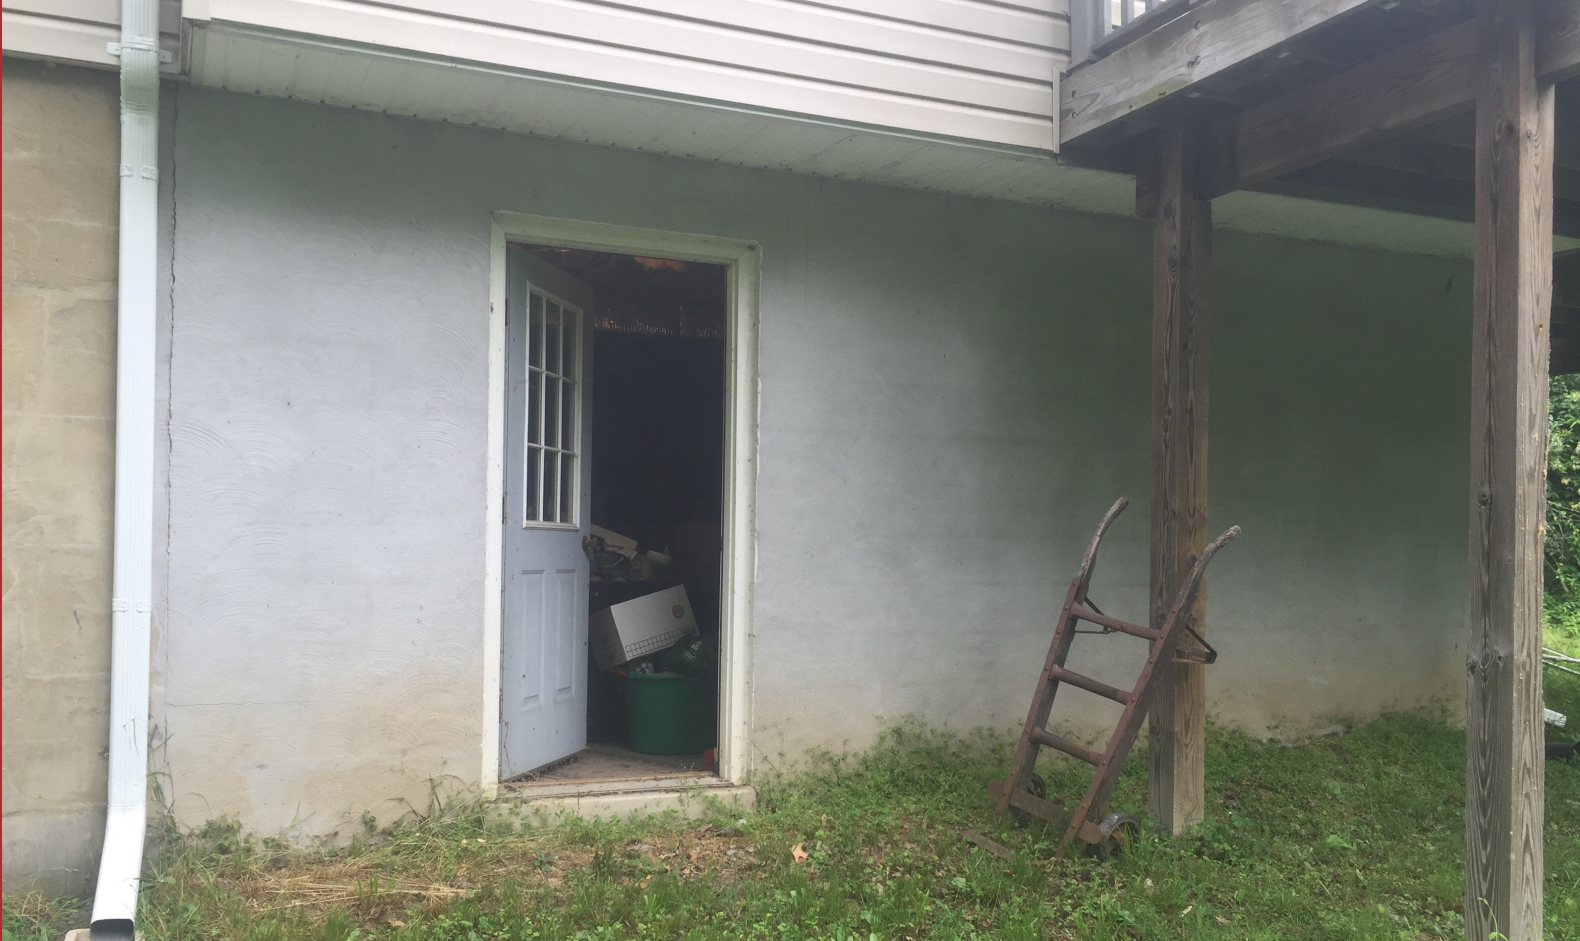
The Mission Home Services company out of Walkersville, Maryland was contacted to assess numerous cracks on the exposed CMU basement walls of a 10 year old addition on a 30+ year old home.

When the addition was built, the exterior wall was not tied into the structure properly. The crack that formed where the new exterior wall of the addition met the existing structure was wider at the top than the bottom, indicating settlement had occurred at the corner of the addition. This settlement also caused cracks to form at the door and window along both the back and side walls of the addition.

contacted the **Rhino Carbon Fiber™** company and after reviewing a variety of options from their line of concrete crack repair and structural strengthening products, determined that 560 GSM in various widths of **Rhino Carbon Fiber™ CFRP (Bidirectional)** would be used on each crack and applied with **RCF™ Saturant-Adhesive Epoxy**. The bidirectional weave orientation was chosen to provide strength across the cracks and help hold sections of the walls together.
