CORNER WRAP CASE STUDY

# BLOCK WALL CORNER REPAIR

Pittsburgh, Pennsylvania

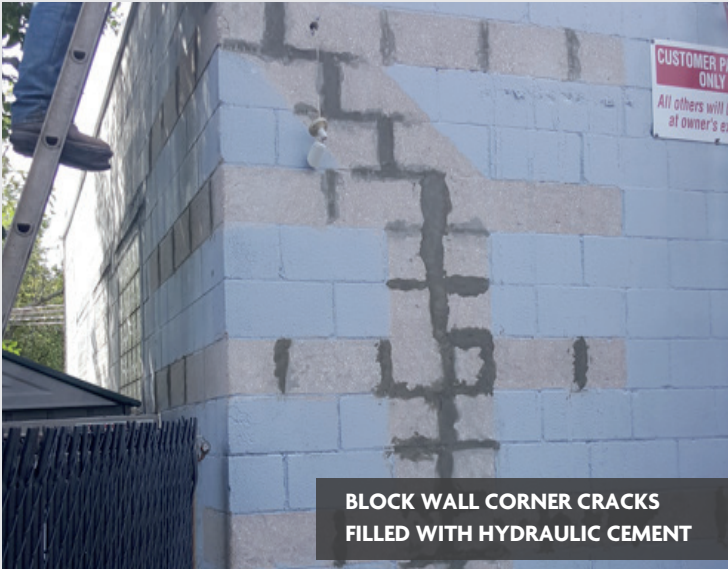
**BLOCK WALL CORNER CRACKS FILLED WITH HYDRAULIC CEMENT**

The block wall was prepped and all mortar joints were filled with hydraulic cement, then the CFRP was installed. The repair avoided using traditional methods that involve excavation and a large footprint, and the project was completed in a timely manner. High quality products from **Rhino Carbon Fiber™** enabled the the Concrete Chiropractor to repair a problem crack that was holding up the sale of the property. Once repainted, the repair blended nicely, effectively restoring the aesthetic appeal and structural integrity of the building.

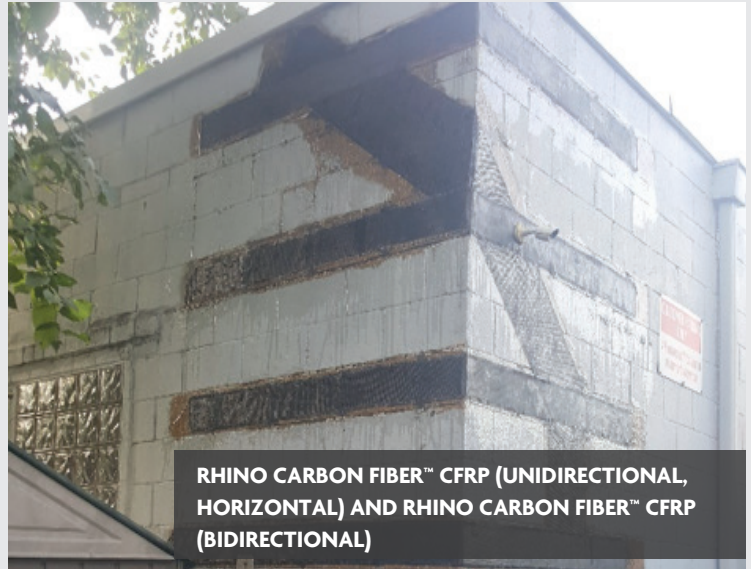
**RHINO CARBON FIBER™ CFRP (UNIDIRECTIONAL, HORIZONTAL) AND RHINO CARBON FIBER™ CFRP (BIDIRECTIONAL)**

The Concrete Chiropractor reviewed the project and their analysis determined that the best solution was to install 400 GSM, 24" wide **Rhino Carbon Fiber™ CFRP (Unidirectional, Horizontal)** over the crack and 560 GSM, 12" wide **Rhino Carbon Fiber™ CFRP (Bidirectional)** over the corner applied with **RCF™ Saturant-Adhesive Epoxy**. This solution was determined to be the best option because if slight movement in the block wall joints remained, CFRP would resist this movement and remain intact.

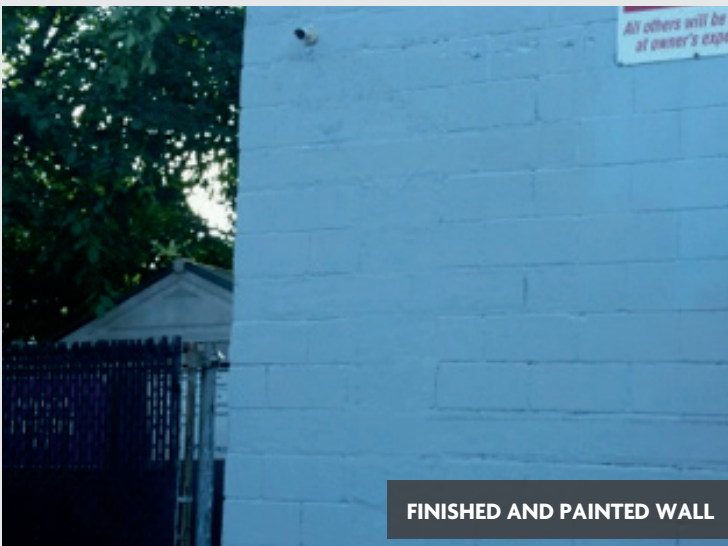
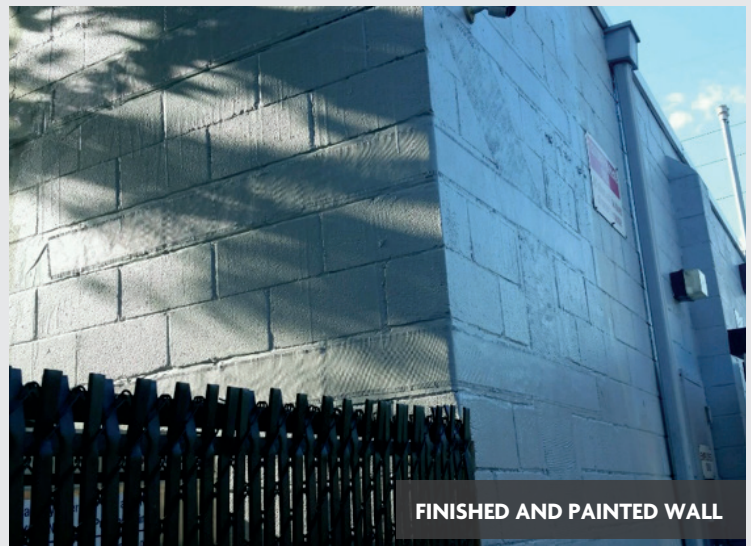
**FINISHED AND PAINTED WALL**
