## CFRP CASE STUDY

# MASONRY WALL REINFORCEMENT: BLAST LOADING UPGRADE

Akron, Ohio

WALLFORCE Foundation Support Systems

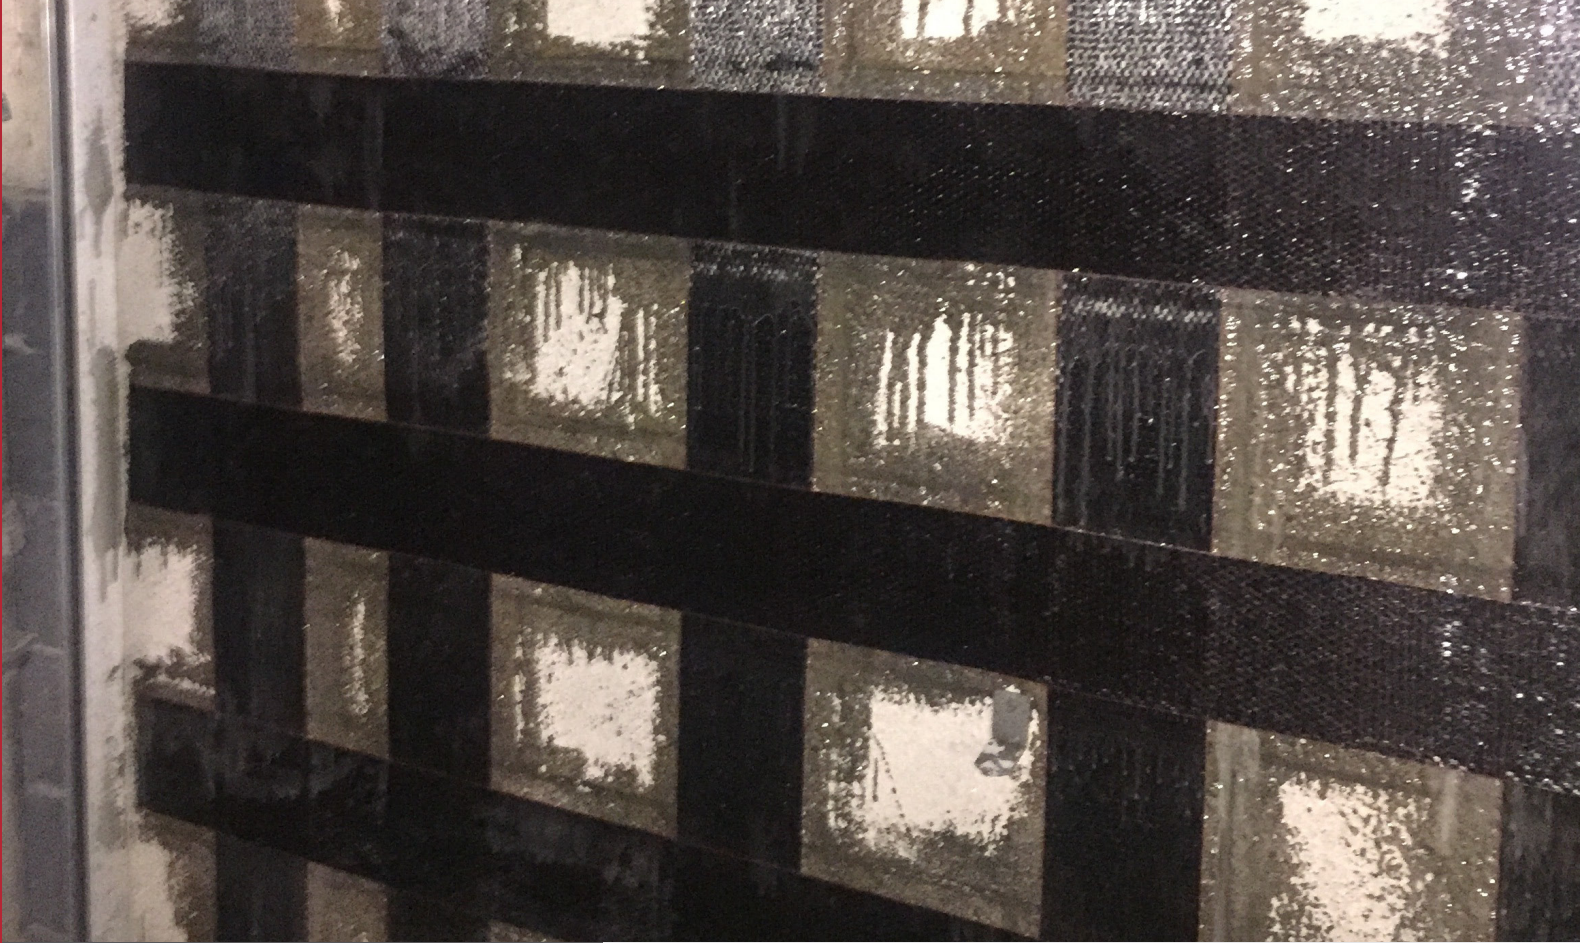
The WALLFORCE Foundation Support Systems company was on a tight schedule to complete the repairs and get the facility operating again, and they engaged Uzman Engineering out of Malvern, PA to put together the structural design to meet the requirements of the project. They determined that they needed to reinforce two sides of a three-story stairwell and several walls in the building.

Upon completion of on-site bond testing in multiple areas within the structure, the WALLFORCE Foundation Support Systems company determined that portions of the existing coating could remain on the walls and that CFRP could be bonded directly to the roughened surface coating. In other areas, the coating bonds failed prematurely or failed between layers so the coating had to be removed before CFRP application.

**RCF™ High Strength Anchoring Epoxy Paste** was used to seal large cracks. To strengthen the stairwell and walls to prevent dynamic cracks, 400 GSM in various widths of **Rhino Carbon Fiber™ CFRP (Unidirectional, Vertical)** and 560 GSM in various widths of **Rhino Carbon Fiber™ CFRP (Bidirectional)** were used, which were applied with **RCF™ Saturant-Adhesive Epoxy**. Different areas within the structure required different weave orientations, weights and widths to meet the requirements for the repairs.
