RHINO
CARBON FIBER
REINFORCEMENT PRODUCTS

CONCRETE CRACK LOCK® STITCHES & CFRP CASE STUDY

SALT BARN CORNER WALL FAILURE REPAIRS

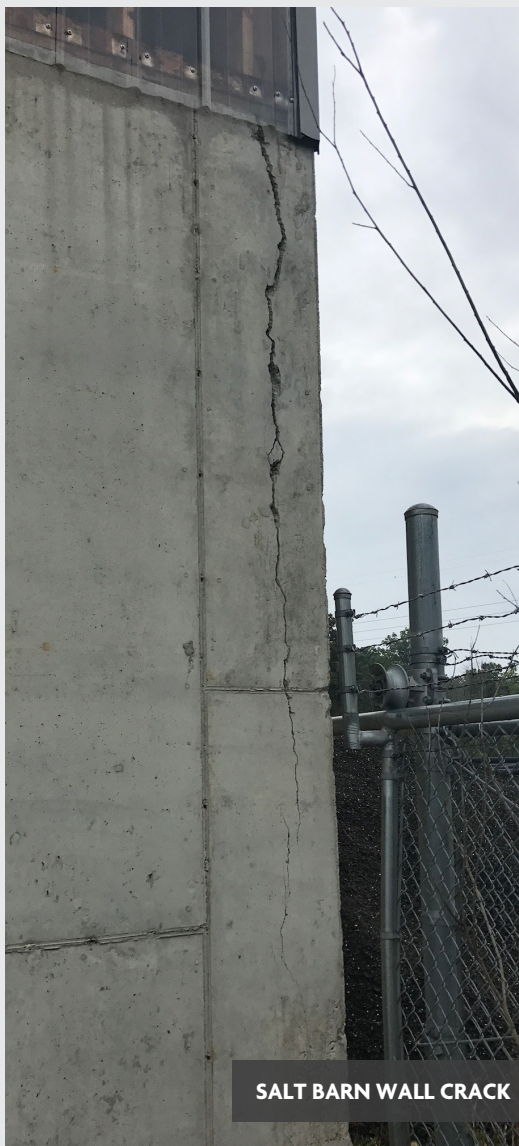
SALT BARN WALL CRACK

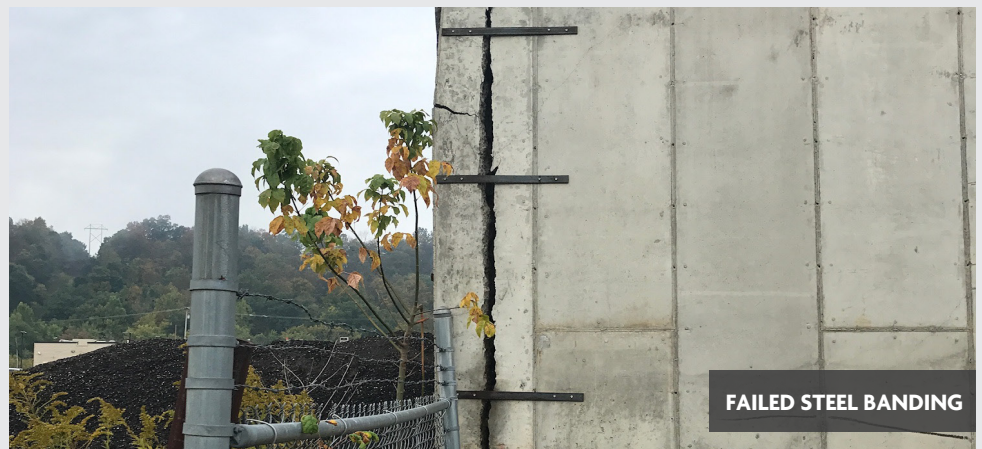
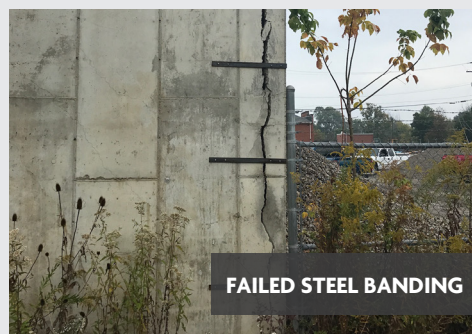
Cracks formed along the back of the storage building structure and the back wall began to tip outward. Initial repairs were performed by first patching the cracks and then adding steel banding to the areas to reinforce the fractures and stop movement. However, since steel is prone to corrosion, these repairs failed incredibly fast. The City then sought another solution.

FAILED STEEL BANDING

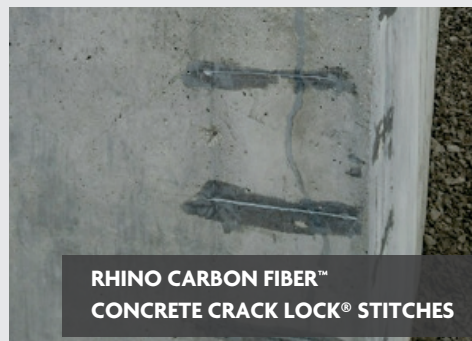
RHINO CARBON FIBER™
CONCRETE CRACK LOCK® STITCHES

The City Engineer reached out to the **Rhino Carbon Fiber™** company and after reviewing the product attributes, studying the technical specifications and contemplating the possible alternatives, he determined that the best solution would be to first patch the cracks with **RCF™ High Strength Anchoring Epoxy Paste** and non-shrink repair mortar, and then reinforce the cracks with **Rhino Carbon Fiber™ Concrete Crack Lock®** stitches. The corners were wrapped with 400 GSM, 24” wide **Rhino Carbon Fiber™ CFRP (Unidirectional, Vertical)** and applied with **RCF™ Saturant-Adhesive Epoxy**.

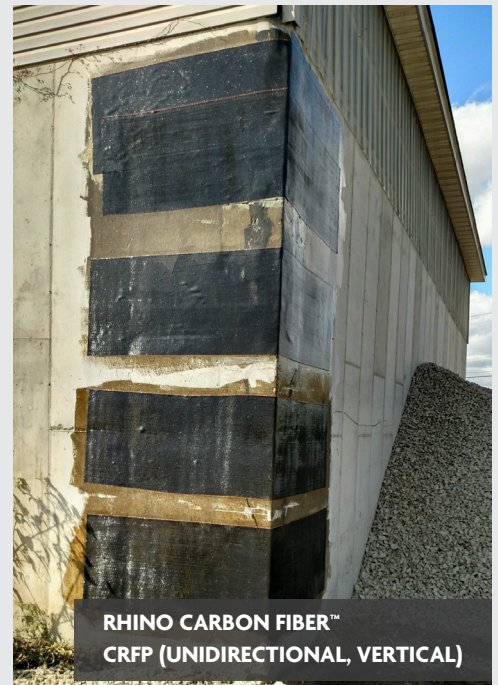
RHINO CARBON FIBER™
CRFP (UNIDIRECTIONAL, VERTICAL)
