#### **CFRP CASE STUDY**

### HISTORICAL WATER TOWER STRENGTHENING WITH CFRP

Clay City, Kansas

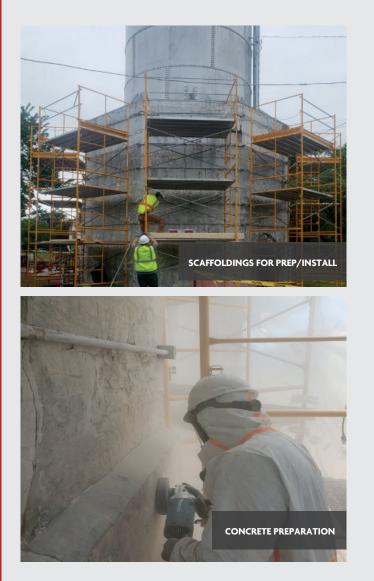
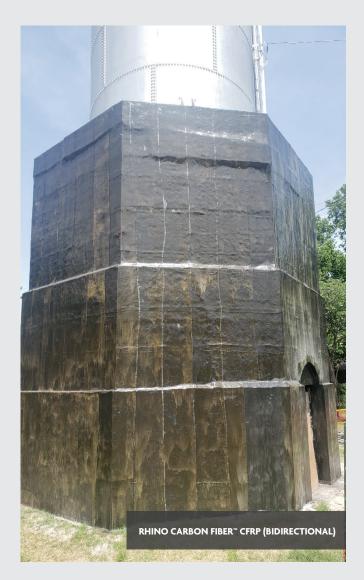
Three crews completed the project applying CFRP to the structure. The base pillar of the tower was entirely encapsulated in CFRP. A cementitious coating, or paint that bonds to CFRP, will be applied after the CFRP cured to restore the exterior appearance and to protect the CFRP from UV light. The end result was that the water tower was successfully restored to operational condition, and the repair was virtually invisible, thanks to the superior properties of CFRP.

Before the CFRP could be installed, the concrete required surface preparation, as preparation is key to ensure a strong bond. The entire surface area of the tower was mechanically abraded, all loose concrete and debris were removed, and large gaps were filled with concrete.
