RHINO
CARBON FIBER
REINFORCEMENT PRODUCTS

CFRP CASE STUDY

BELOW GRADE GYMNASIUM WALL STABILIZATION

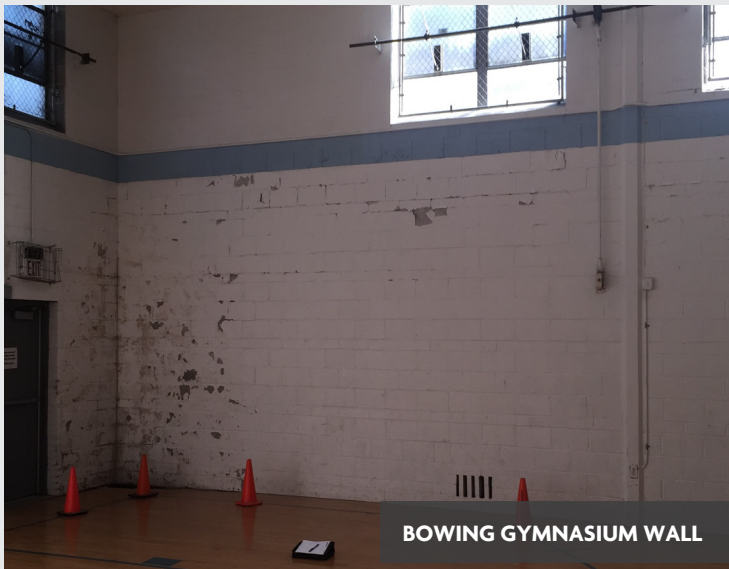
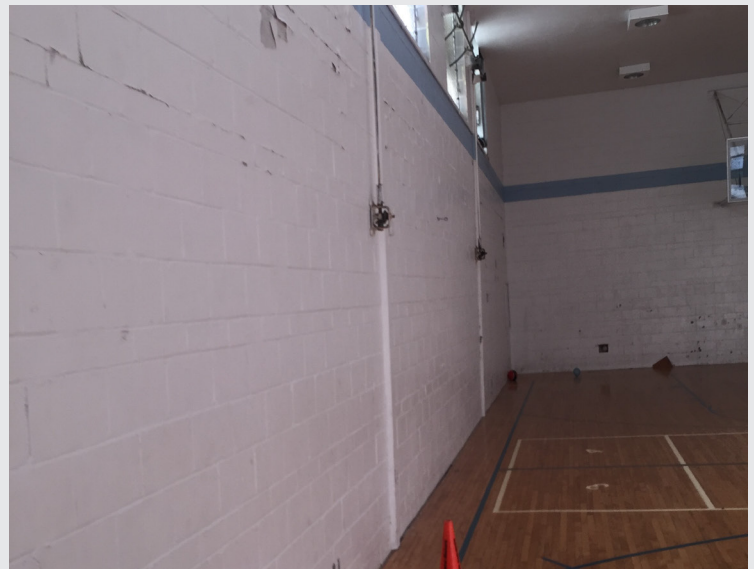
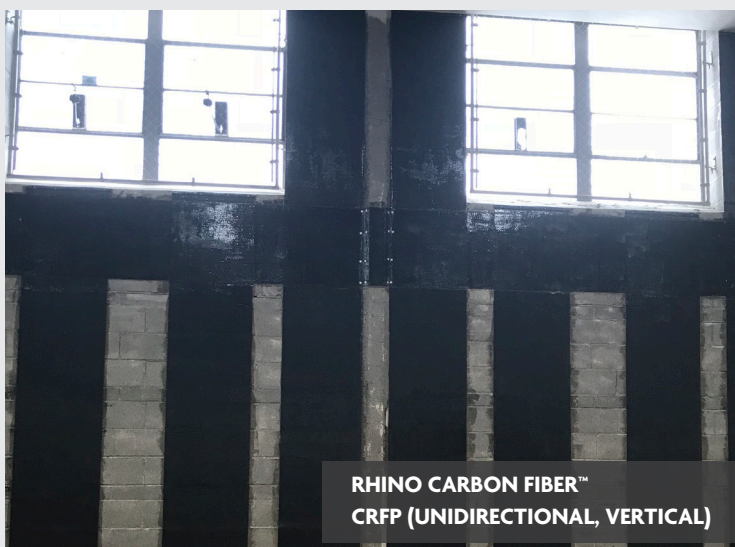
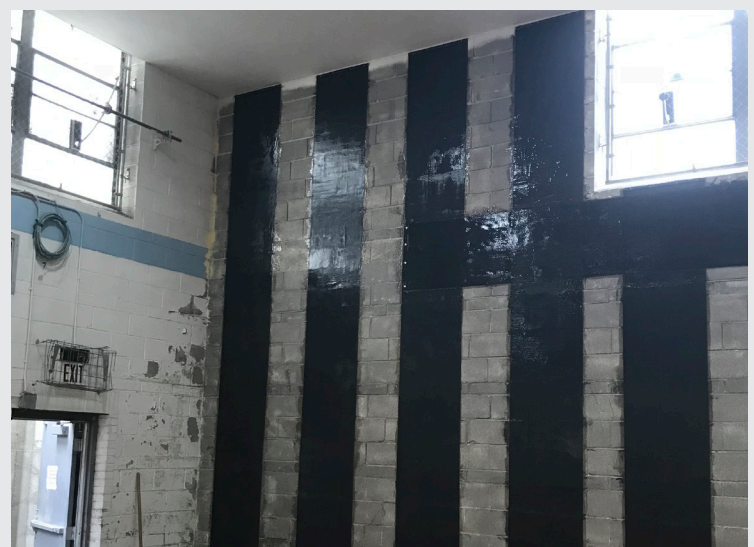
Once the water issue was addressed, it was time to strengthen the wall to prevent any further movement. 400 GSM, 24” wide **Rhino Carbon Fiber™ CFRP (Unidirectional, Vertical)** was applied with **RCF™ Saturant-Adhesive Epoxy**. CFRP was also installed under the windows to transfer the load.

Due to the size of the wall and the amount of surface preparation work required for the CFRP installation, the Epp Concrete Construction company elected to bring in a subcontractor to sandblast the entire wall. Per ICRI 310-2R, the surface profile of the concrete prior to CFRP installation should be a CSP 4. Once the blasting was completed, the crew was able to proceed with the CFRP installation.
