RHINO
CARBON FIBER
REINFORCEMENT PRODUCTS

CFRP CASE STUDY

CRACK REPAIR & CONFINEMENT

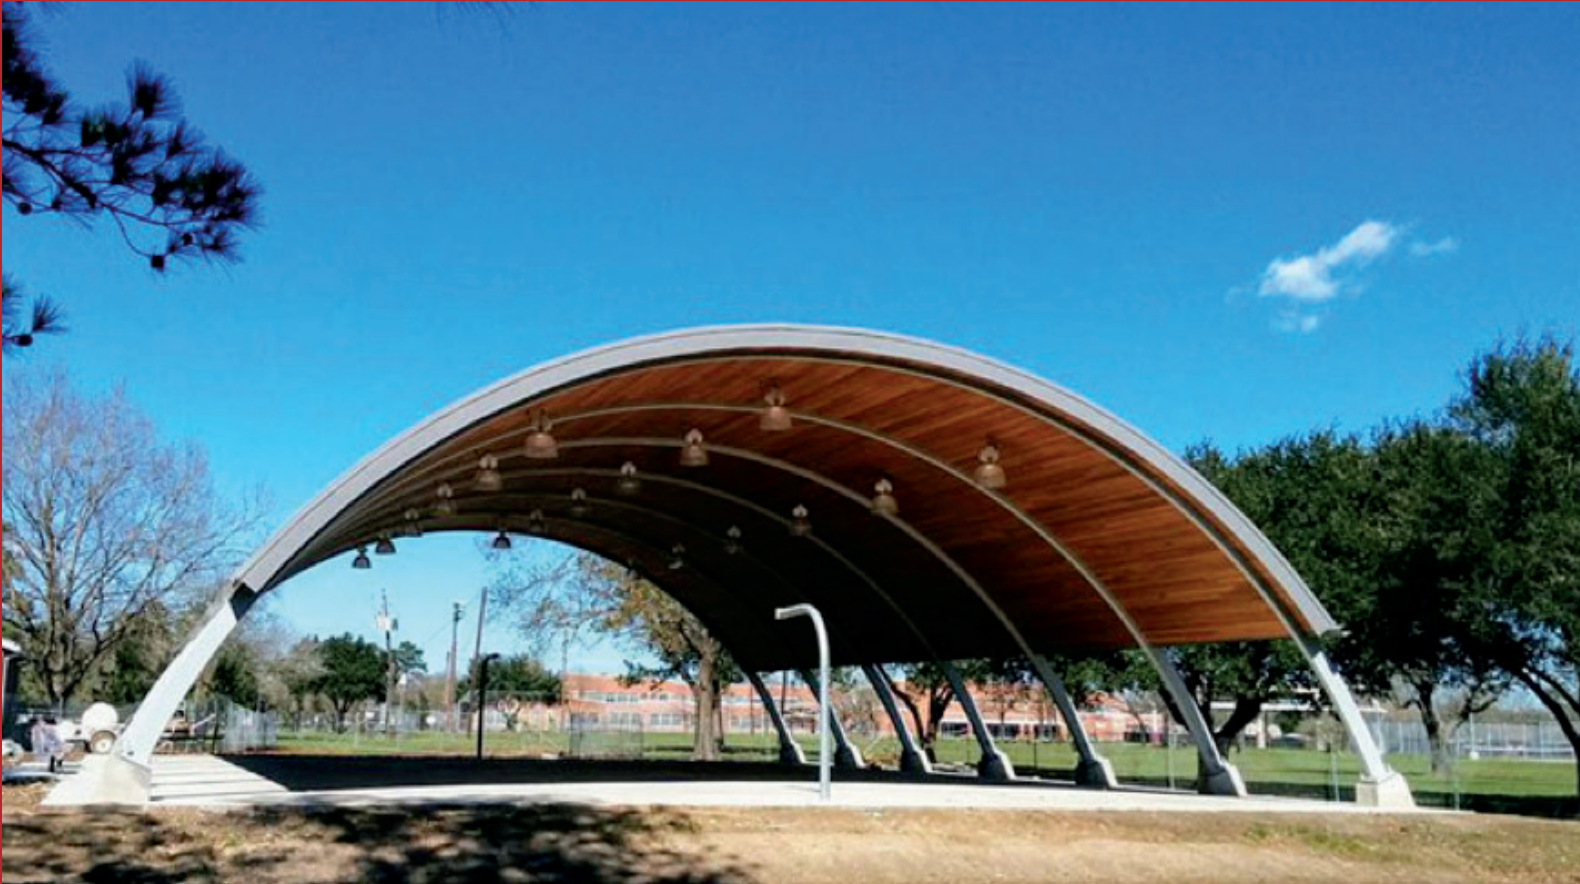
During the erection of the arches, the base plates had to be slid over anchor bolts that were cast into the thrust blocks and some cracking occurred around the anchor bolts on a few of the thrust blocks.

The Gadberry Construction Company worked with The City of Houston's structural engineers to come up with the appropriate solution for the thrust block repairs. They determined that the best solution was to first inject the thrust blocks with **RCF™ Structural Epoxy Injection Resin**, and then wrap the blocks with 560 GSM, 24" wide **Rhino Carbon Fiber™ CFRP (Bidirectional)** applied with **RCF™ Saturant-Adhesive Epoxy**. The Gadberry Construction Company hired Olshan Foundation Repair Co. of Houston, LLC to complete the repair.

After the CFRP installation per sub paragraph 2 of Item 786 of the standard, the contractor had to provide appearance coating recommended by a CFRP system manufacturer to protect the CFRP from ultraviolet radiation, and match color of the protective appearance coating to adjacent concrete. Elastomeric stucco was used to protect the CFRP and give the City a maintenance free coating that would not crack over time.

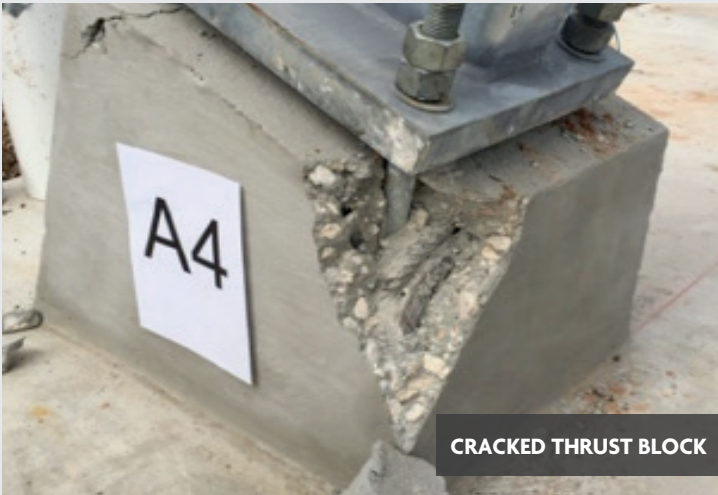
CRACKED THRUST BLOCK

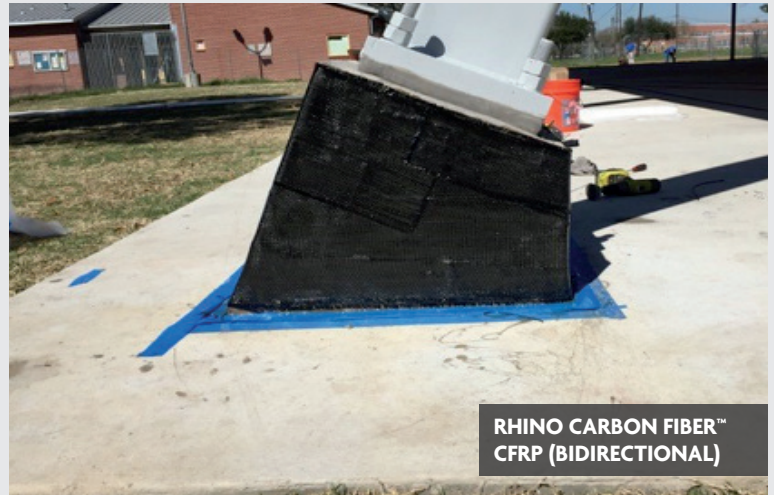
RHINO CARBON FIBER™
CFRP (BIDIRECTIONAL)

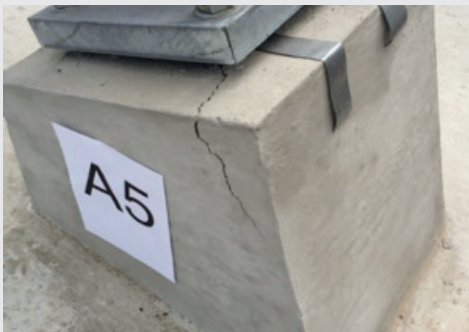
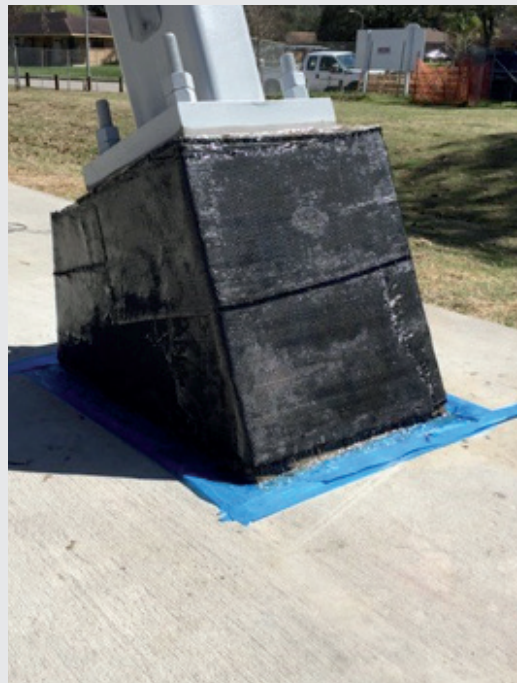
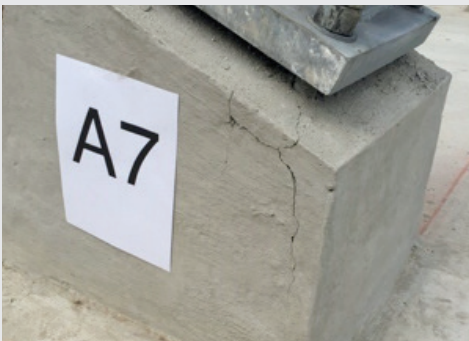
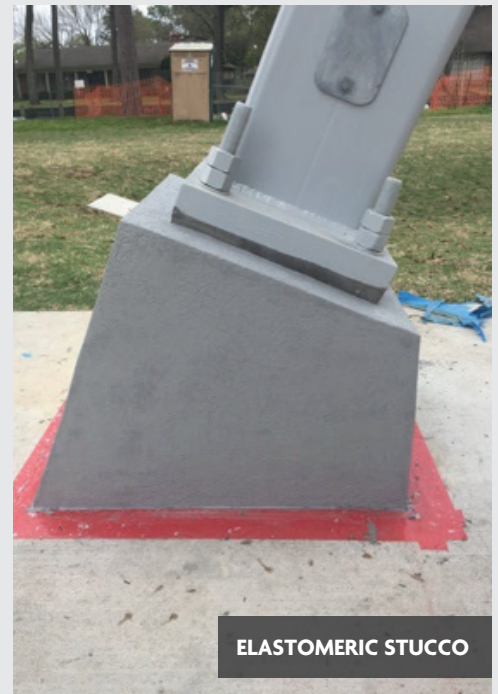
ELASTOMERIC STUCCO
