RHINO
CARBON FIBER
REINFORCEMENT PRODUCTS

CFRP CASE STUDY

BEAM FLEXURE STRENGTH TEST

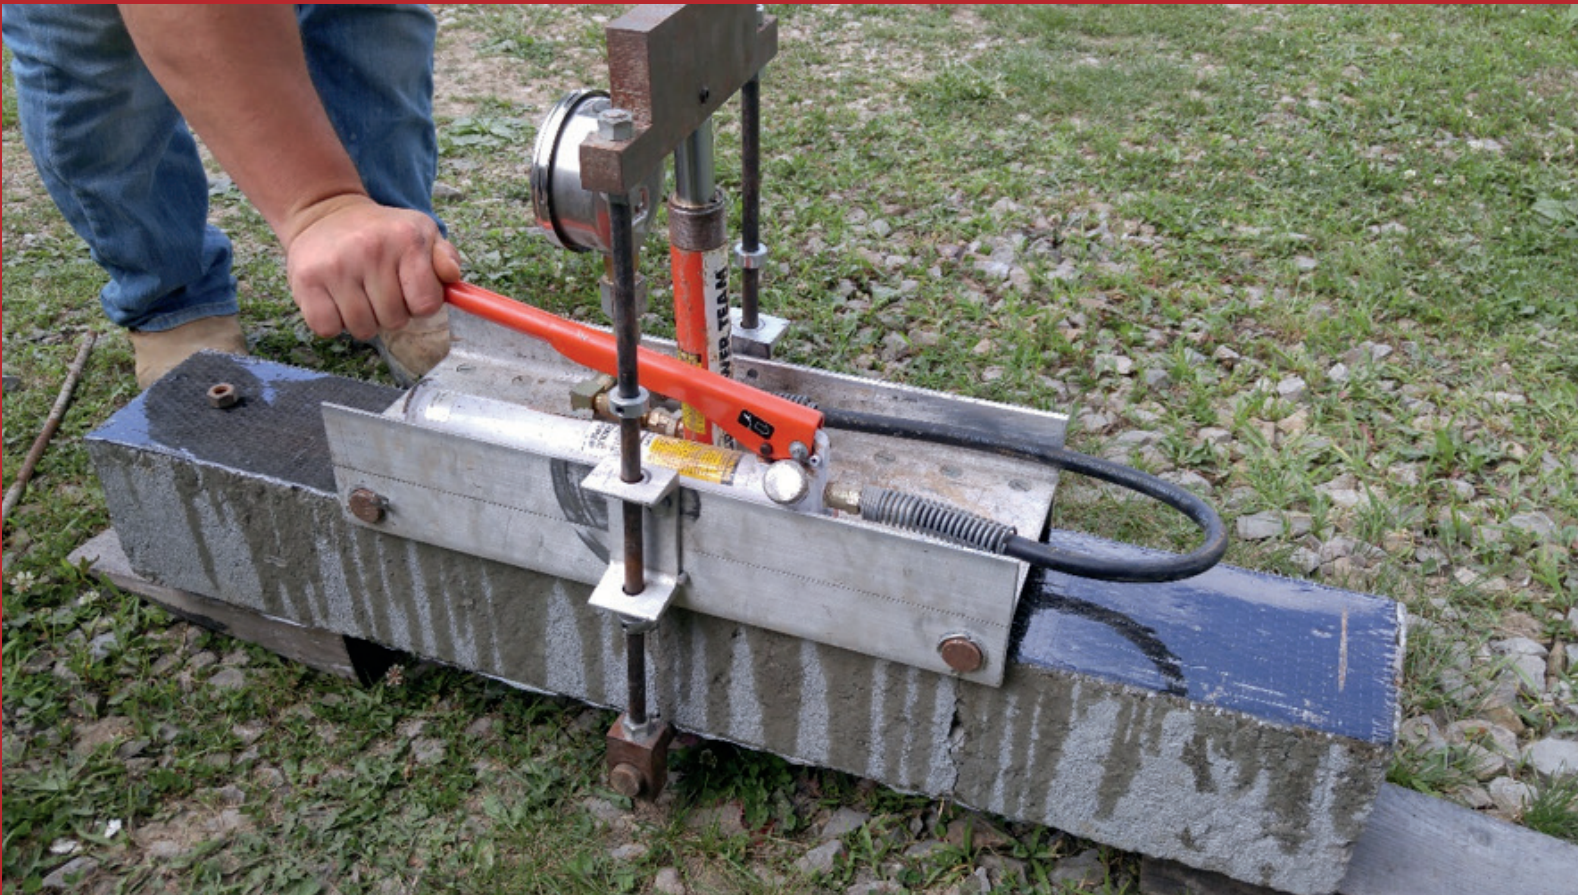
The **Rhino Carbon Fiber™** company obtained a beam that had been broken twice in a flexure test from a local project, and pulled it back together with a ratchet strap.

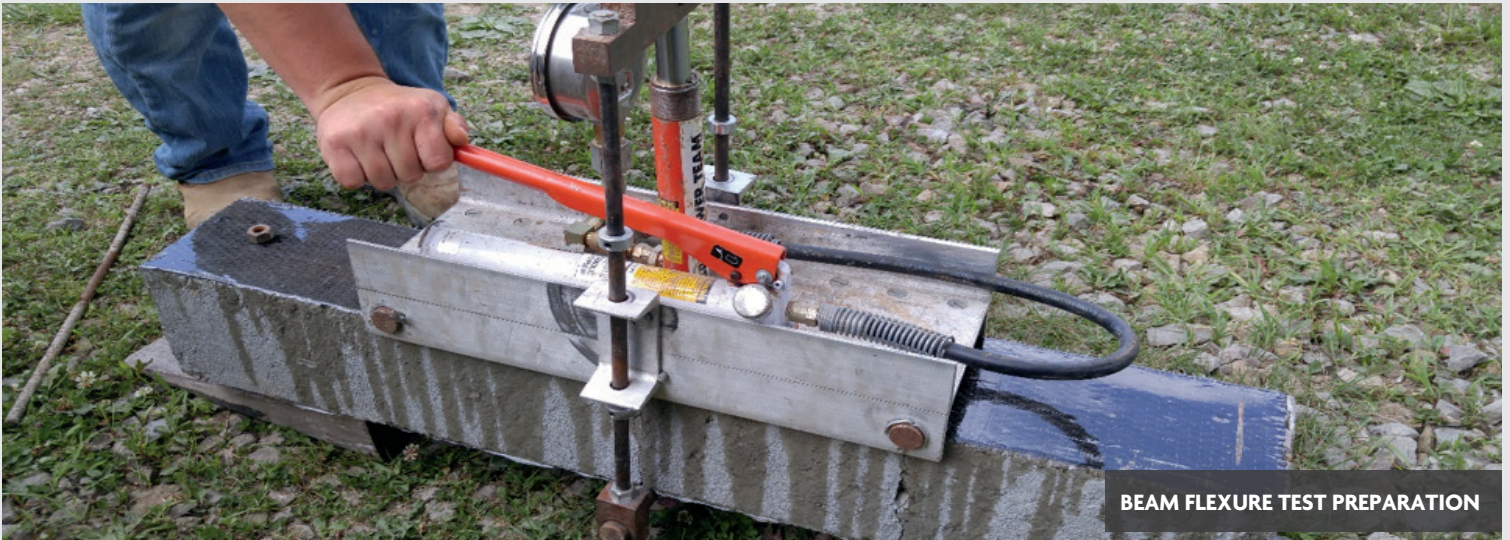
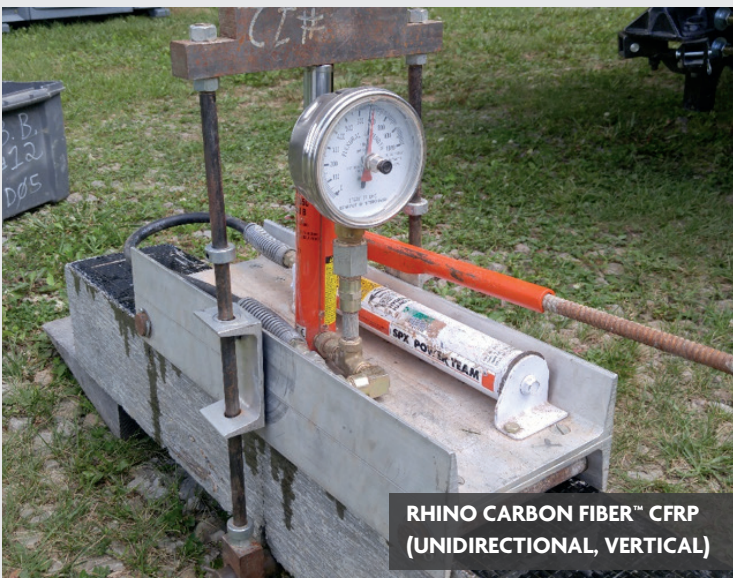
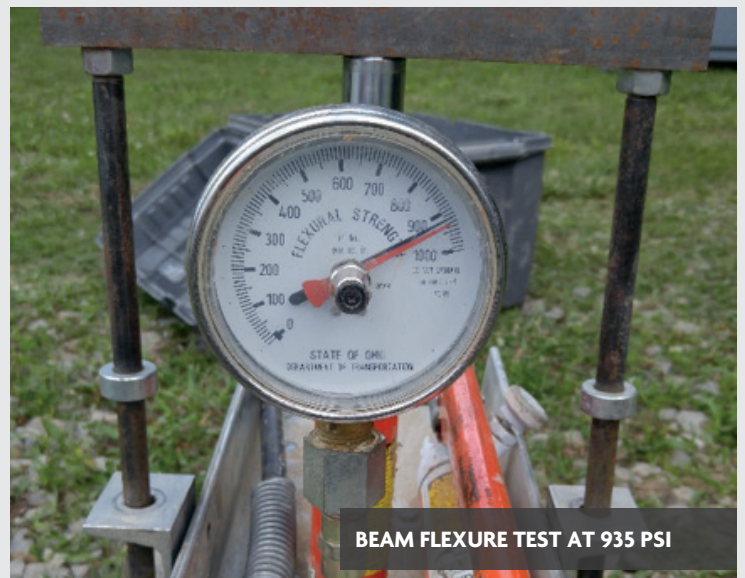
400 GSM, 6" wide **Rhino Carbon Fiber™** CFRP (Unidirectional, Vertical) was applied to the beam with **RCF™ Saturant-Adhesive Epoxy**. Once the epoxy was cured, the same flexure test was performed on the beam that broke originally. The load was placed at the location of the prior break and taken up to 650psi, the strength required to proceed with loading newly poured concrete on Ohio Department of Transportation (ODOT) projects. The result of this test was that the concrete had gained strength although the beam was already broken.

The load was then taken up to 935 psi and the test was performed over both of the prior breaks - the carbon fiber did not fail.

Since the concrete was already broken at the test locations, the flexural resistance that we saw was solely showing the strength of the CFRP in conjunction with epoxy, and its bond to the concrete. This is just one illustration of the potential use of **Rhino Carbon Fiber™** products for concrete crack repair and structural strengthening. Results may vary and each case is unique. Consult your engineer to determine if **Rhino carbon Fiber™** products are right for your project.
