RHINO
CARBON FIBER
REINFORCEMENT PRODUCTS

CFRP CASE STUDY

STADIUM SUPPORT COLUMN REPAIR

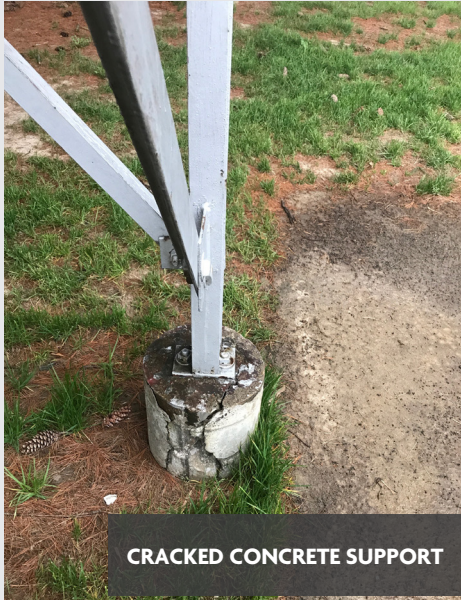
CRACKED CONCRETE SUPPORT

The concrete supports were badly deteriorated and in need of repair, and the LAN Concrete Technology company determined the supports would be excavated one foot below grade so that CFRP could be installed around each support. The supports were wrapped with 560 GSM, 12" wide **Rhino Carbon Fiber™ CFRP (Bidirectional)** and applied with **RCF™ Saturant-Adhesive Epoxy**. This method repaired and strengthened the supports, effectively restoring the integrity of the structure. After the CFRP installation, the supports were coated in a UV Resistant Coating which made the repairs look aesthetically pleasing. By using **Rhino Carbon Fiber™** products, the LAN Concrete Technology company was able to eliminate the access issues with transporting concrete to each one of the support locations and was able to provide an aesthetically appealing CFRP repair.

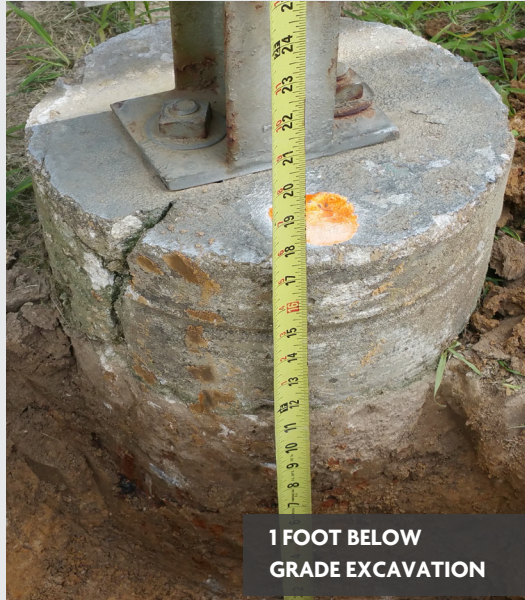
1 FOOT BELOW
GRADE EXCAVATION

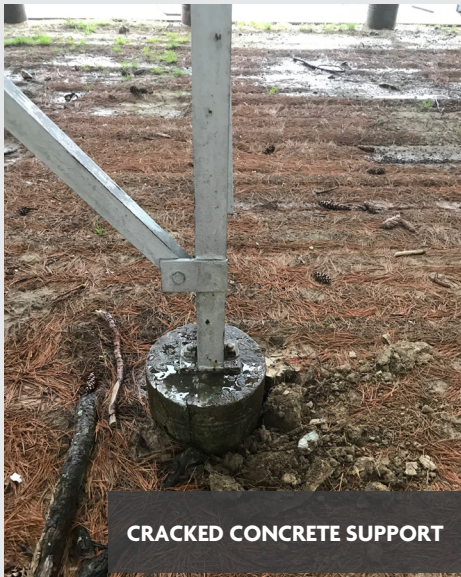
CRACKED CONCRETE SUPPORT

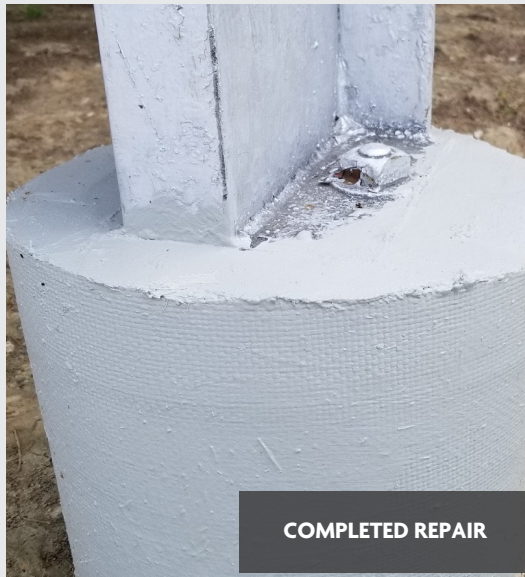
COMPLETED REPAIR

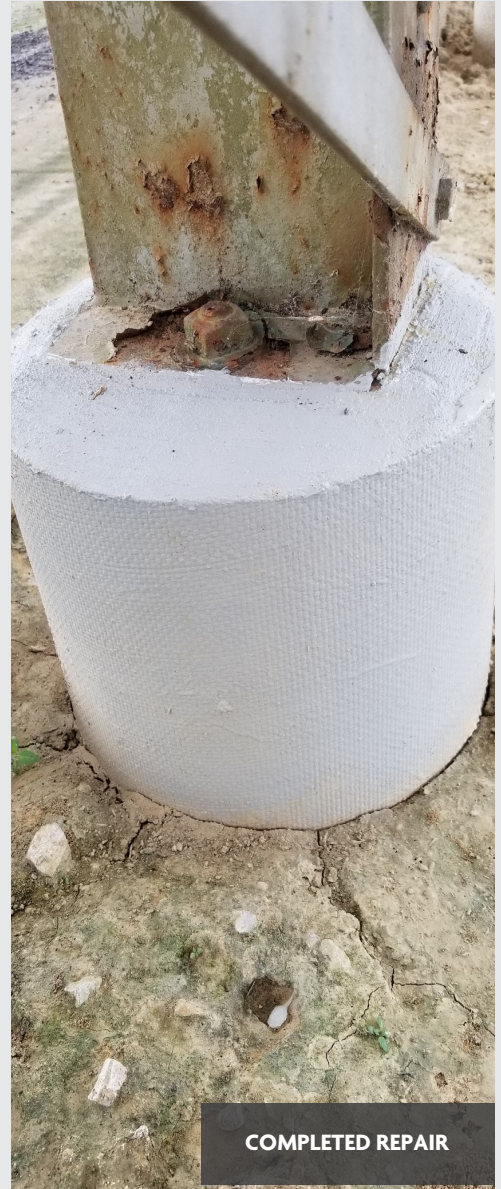
COMPLETED REPAIR
