RHINO
CARBON FIBER
REINFORCEMENT PRODUCTS

CFRP CASE STUDY

CRACK REPAIR & CONFINEMENT

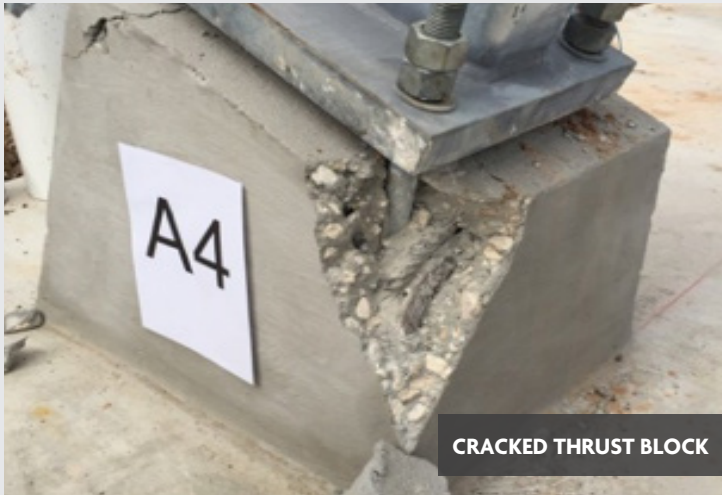
During the erection of the arches, the base plates had to be slid over anchor bolts that were cast into the thrust blocks and some cracking occurred around the anchor bolts on a few of the thrust blocks.

CRACKED THRUST BLOCK

The Gadberry Construction Company worked with The City of Houston's structural engineers to come up with the appropriate solution for the thrust block repairs. They determined that the best solution was to first inject the thrust blocks with **RCF Structural Epoxy Injection Resin**, and then wrap the blocks with 560 GSM, 24" wide **Rhino Carbon Fiber CFRP (Bidirectional)** applied with **RCF Saturant-Adhesive Epoxy**. The Gadberry Construction Company hired Olshan Foundation Repair Co. of Houston, LLC to complete the repair.

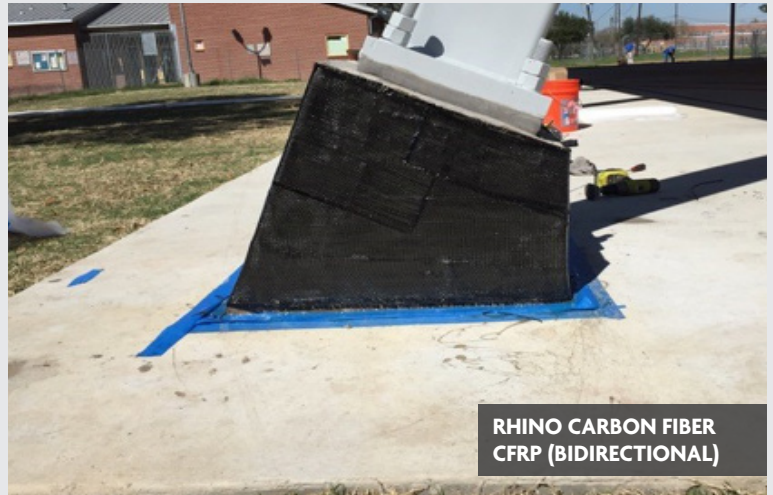
RHINO CARBON FIBER
CFRP (BIDIRECTIONAL)

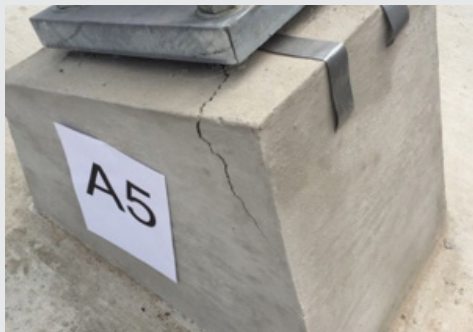
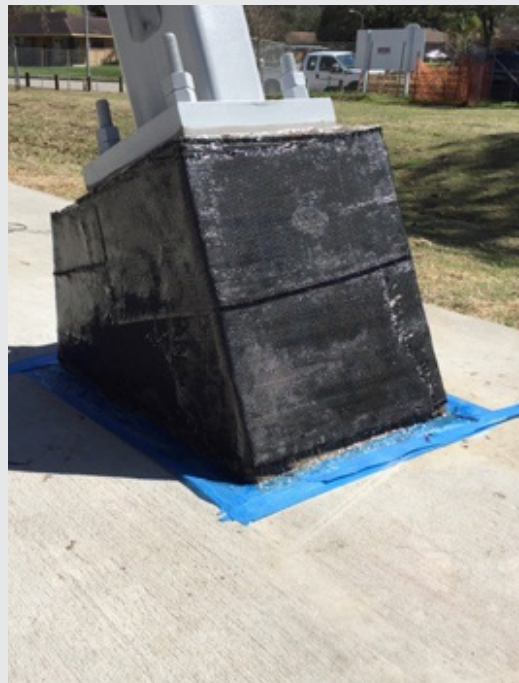
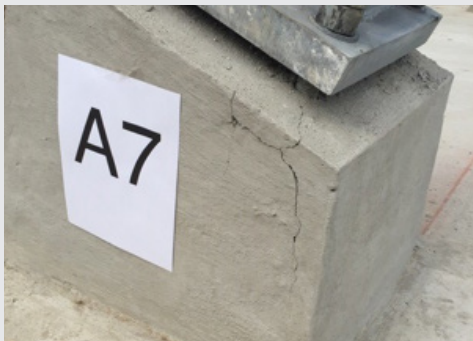
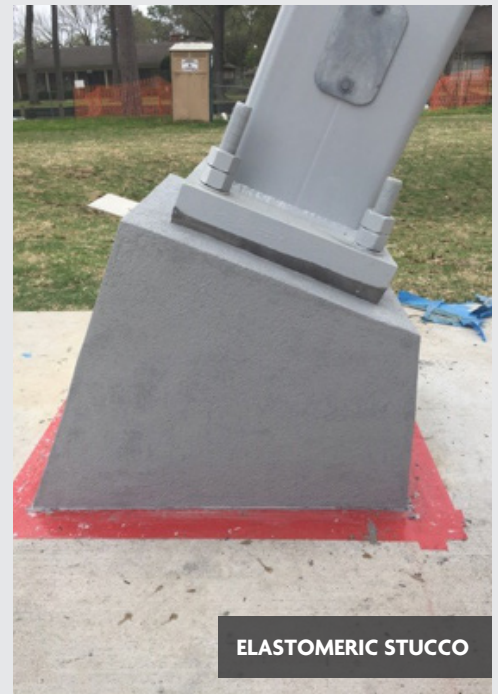
ELASTOMERIC STUCCO

After the CFRP installation per sub paragraph 2 of Item 786 of the standard, the contractor had to provide appearance coating recommended by a CFRP system manufacturer to protect the CFRP from ultraviolet radiation, and match color of the protective appearance coating to adjacent concrete. Elastomeric stucco was used to protect the CFRP and give the City a maintenance free coating that would not crack over time.
