RHINO
CARBON FIBER
REINFORCEMENT PRODUCTS

CFRP CASE STUDY

STRENGTHENING CONCRETE SILOS WITH CFRP

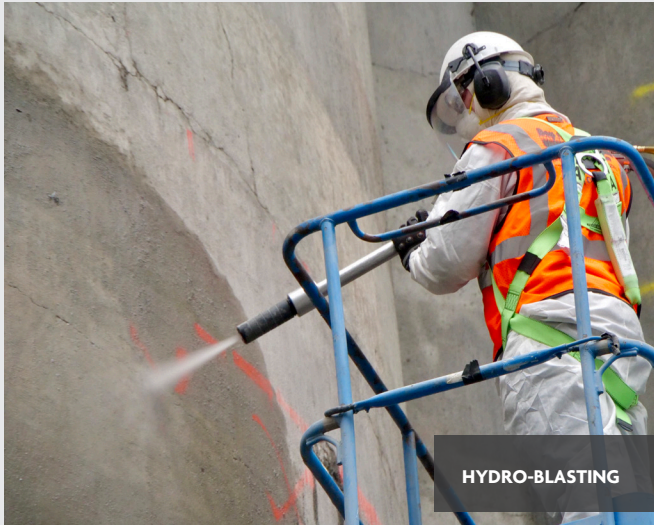
HYDRO-BLASTING

Surface preparation of the concrete is critical to ensure a strong epoxy bond. Two crews of four marked the locations where the CFRP straps would be applied with spray paint. Then the entire surface area was hydro-blasted within the marked areas in order to obtain a clean surface with absence of the laitance layer and with adequate roughness level. They utilized a “hoop-strength reinforcement” method of application for the CFRP, which refers to wrapping around the silos like a belt.

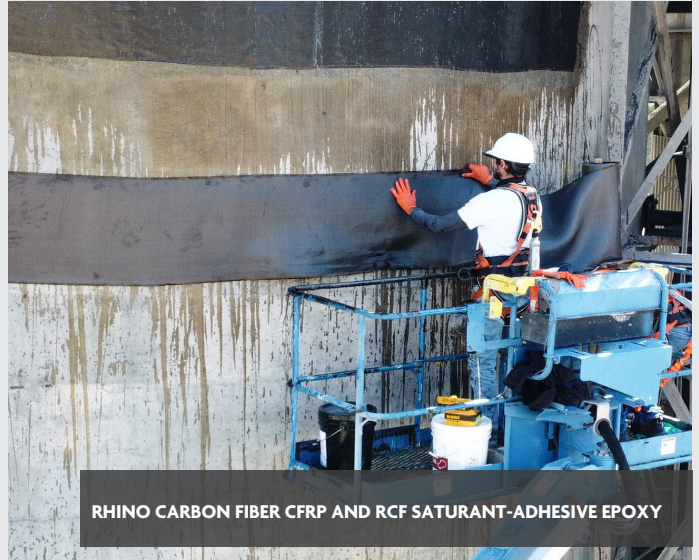
RHINO CARBON FIBER CFRP AND RCF SATURANT-ADHESIVE EPOXY

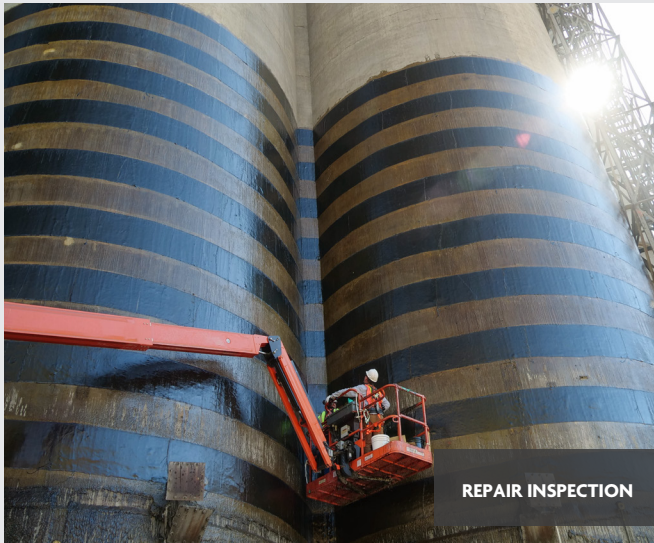
REPAIR INSPECTION

As a final step, the CFRP was covered with a UV-resistant coating to protect the CFRP system from UV light deterioration. Upon completion, the silos were effectively restored and are operating at 100% capacity.
